# Manhole Inspection Summary

Manhole # S49K\_\_014MH

Insp Date: **3/27/08 9:19 AM**

**Location** Address: **S Glover St Lakewood**

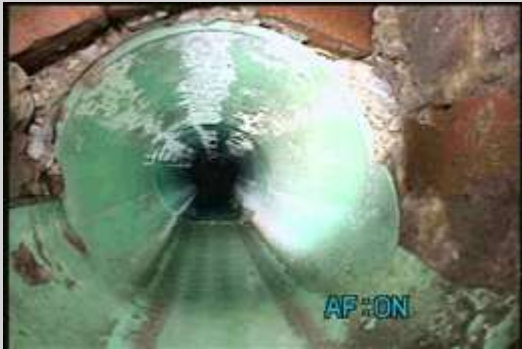
12 O'Clock Outflow

10 in. Circular Gravity Sewer  
Pipe Out @ 12 O'Clock

Pipe Height: 0 (in.) Direct

Pipe Material: PVC ☐ Pipe Lined

Invert Depth: 9.16 (ft.) Flow Characteristics: Fast

Deposits: ☒ None ☐ Mud ☐ Sludge ☐ Debris ☐ Grease

Infiltration: None Pipe Seal Cond: Unknown

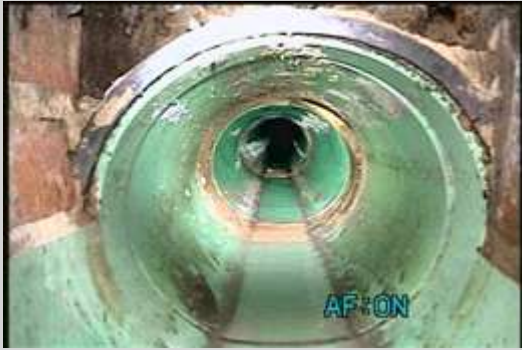
6 O'Clock Inflow

10 in. Circular Gravity Sewer  
Pipe In @ 6 O'Clock

Pipe Height: **0** (in.) Direct

Pipe Material: **PVC** ☐ Pipe Lined

Infiltration: **None** Pipe Seal Cond: **Unknown**
